# **Selected Images of the Effects of the October 15, 2006, Kīholo Bay-Māhukona, Hawai‘i, Earthquakes and Recovery Efforts**

Data Series 506

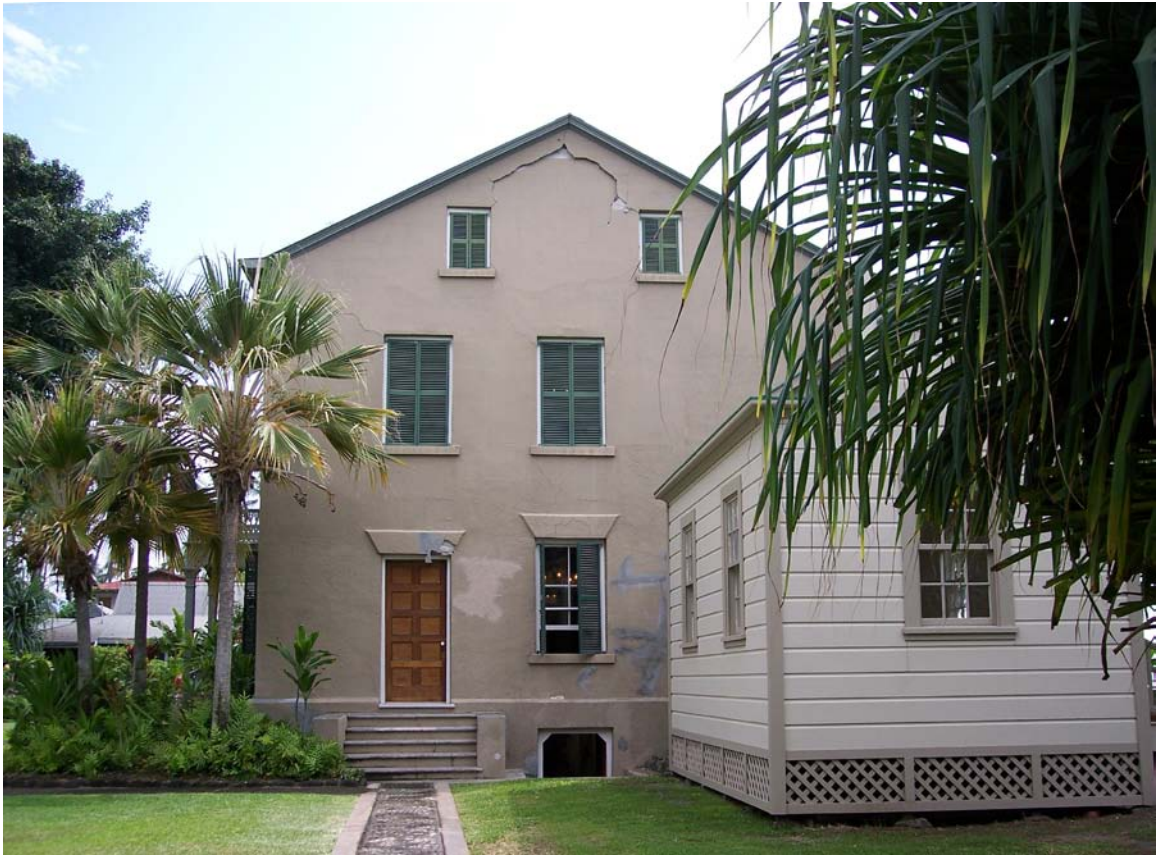
33.9. View of cracks in the stucco façade of the north gable at Hulihe'e Palace—under the peak of the roof between the upper two windows, above the damaged door frame, and between the lower window and the white-painted building (view to the south). USGS photo by T.J. Takahashi, 10/28/2006 (tjt1731).

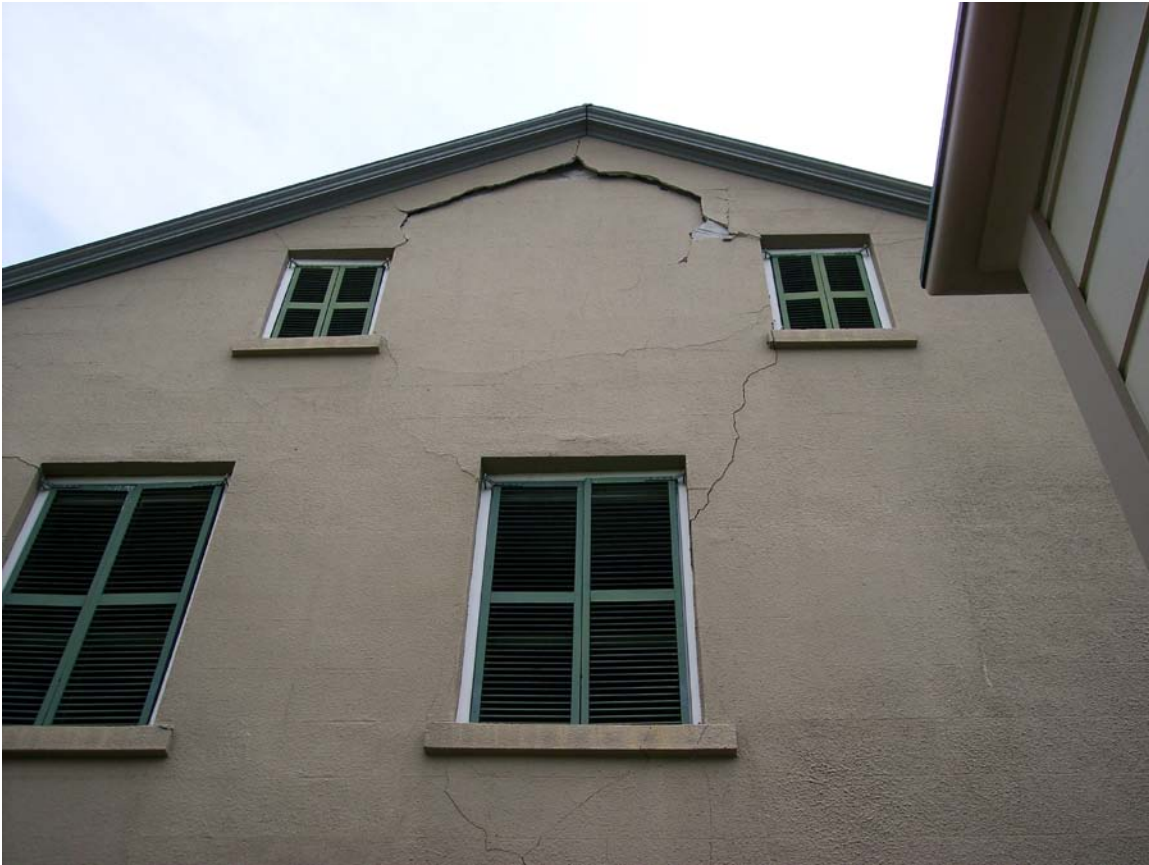
33.10. Close-up view of the crack in the stucco façade under the pitch of the roof. Smaller cracks can be seen all over the wall (view to the southeast). USGS photo by T.J. Takahashi, 10/28/2006 (tjt1726).

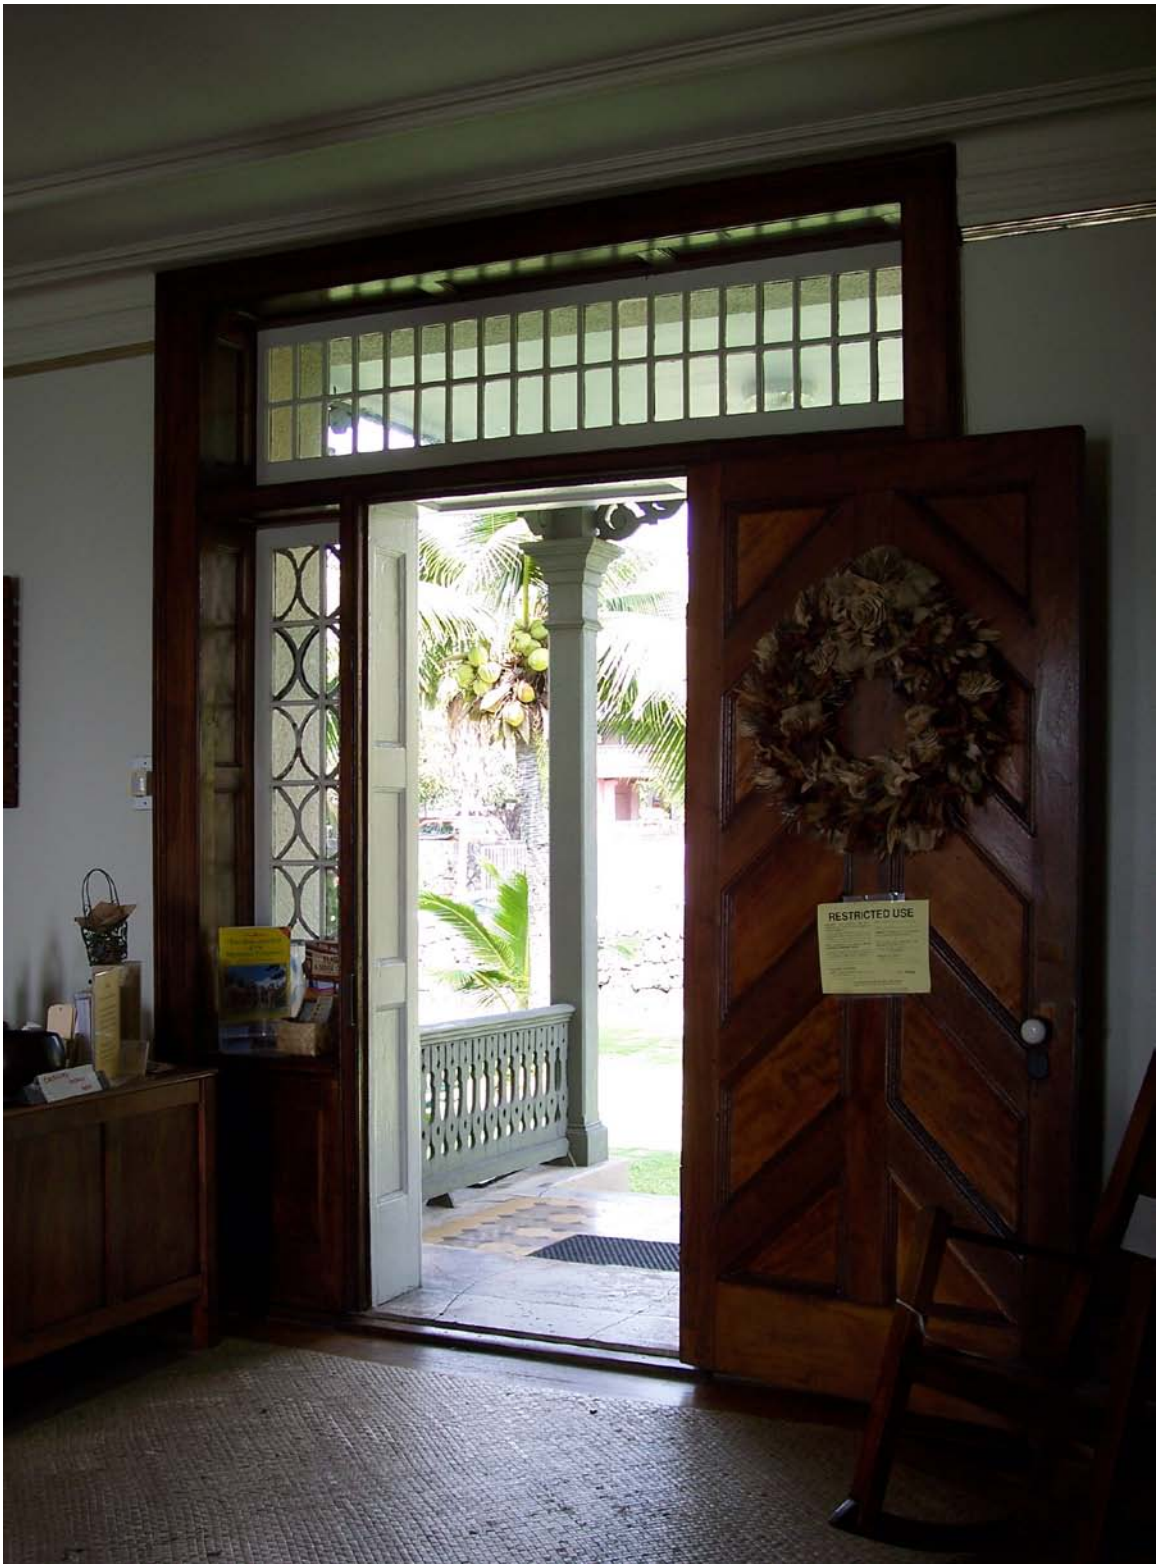
33.11. View from the front entrance of Hulihe'e Palace, looking out. Note restricted-use notice attached to the wreath-hung koa door. There are also cracks in the entrance of the concrete walkway (view to the north). USGS photo by T.J. Takahashi, 10/28/2006 (tjt1883).

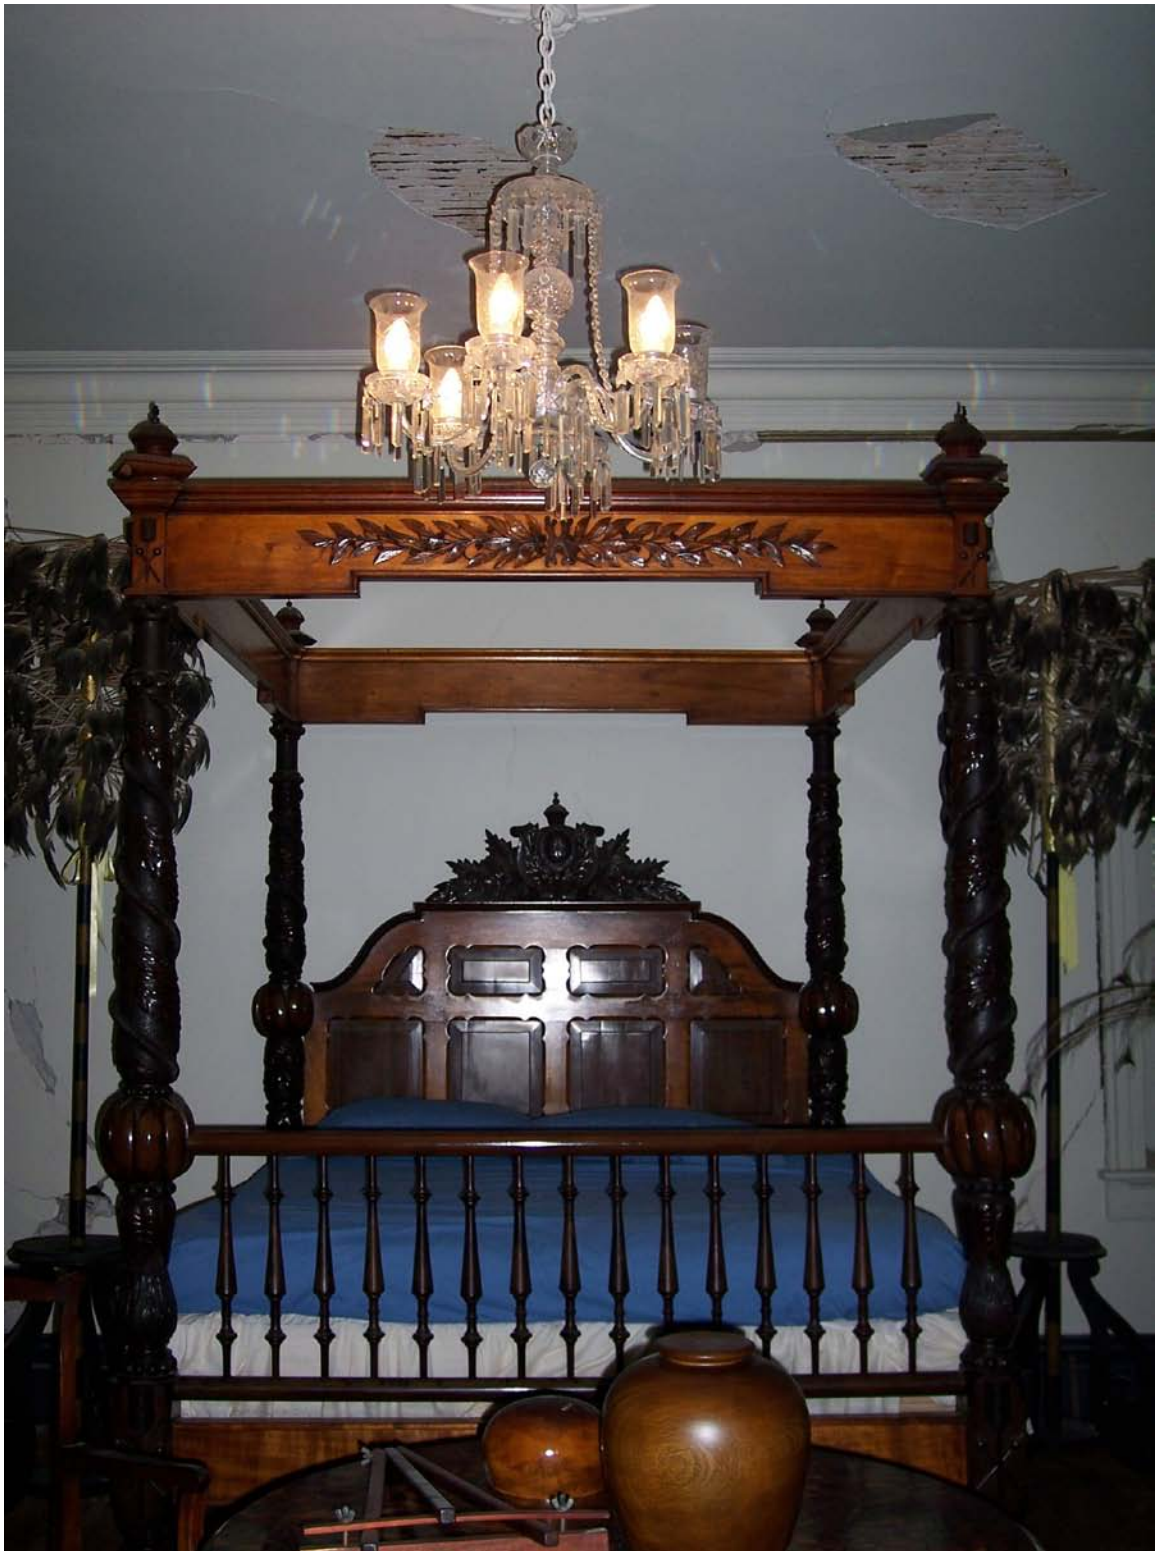
33.12. View of the chandelier and the koa bed for visiting royalty that were unscathed by the earthquake, but the ceiling and walls surrounding them were extensively damaged (view to the south). USGS photo by T.J. Takahashi, 10/28/2006 (tjt1833).

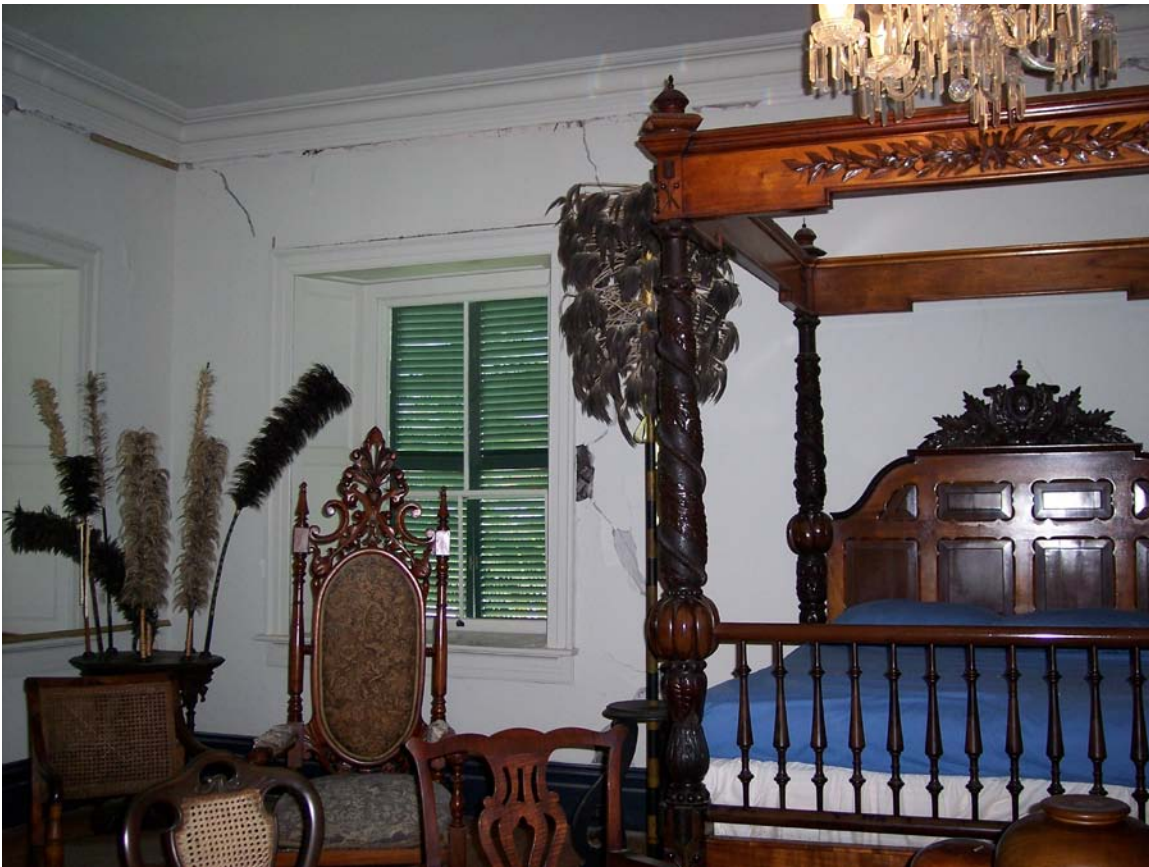
33.13. Close-up view of damage along the upper wall, near the ceiling, and alongside the window framing in the bedroom for visiting royalty (view to the southeast). USGS photo by T.J. Takahashi, 10/28/2006 (tjt1836).

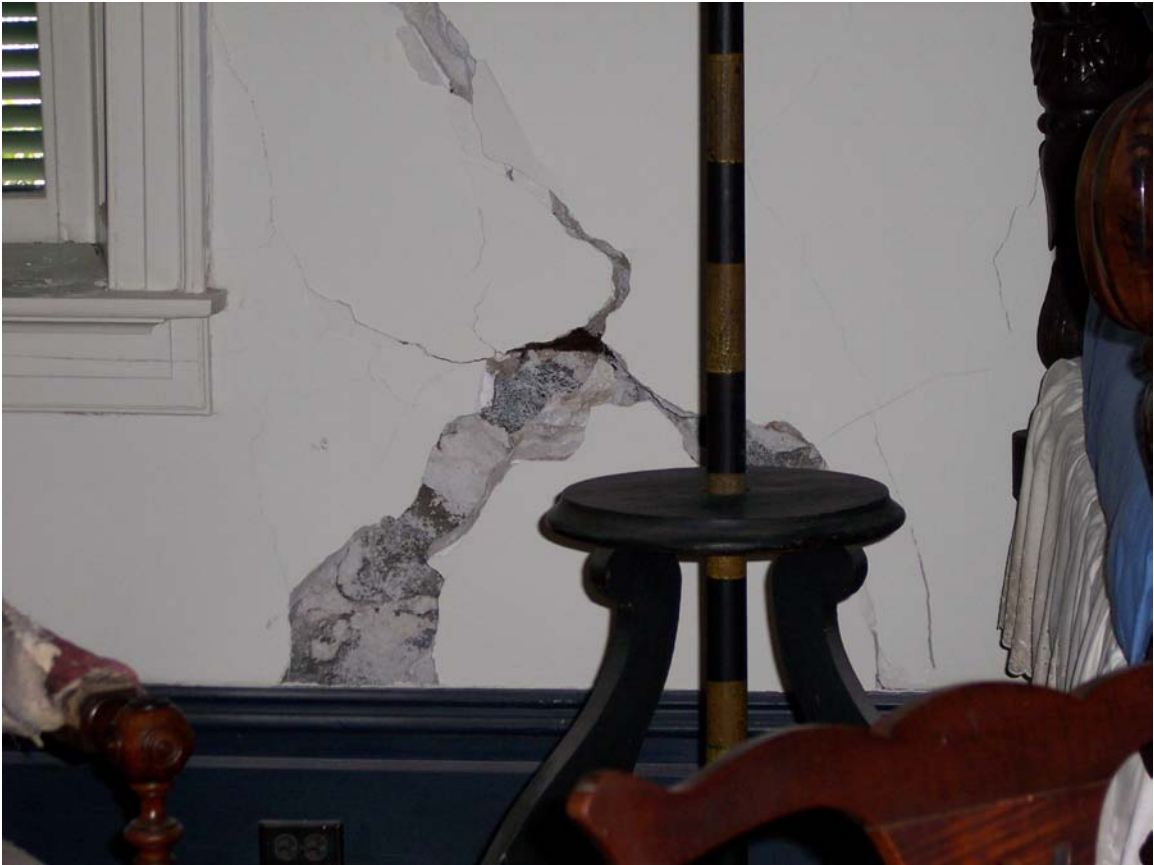
33.14. Close-up view of cracked wall plaster, showing interior stone work in the bedroom for visiting royalty (view to the south). USGS photo by T.J. Takahashi, 10/28/2006 (tjt1817).

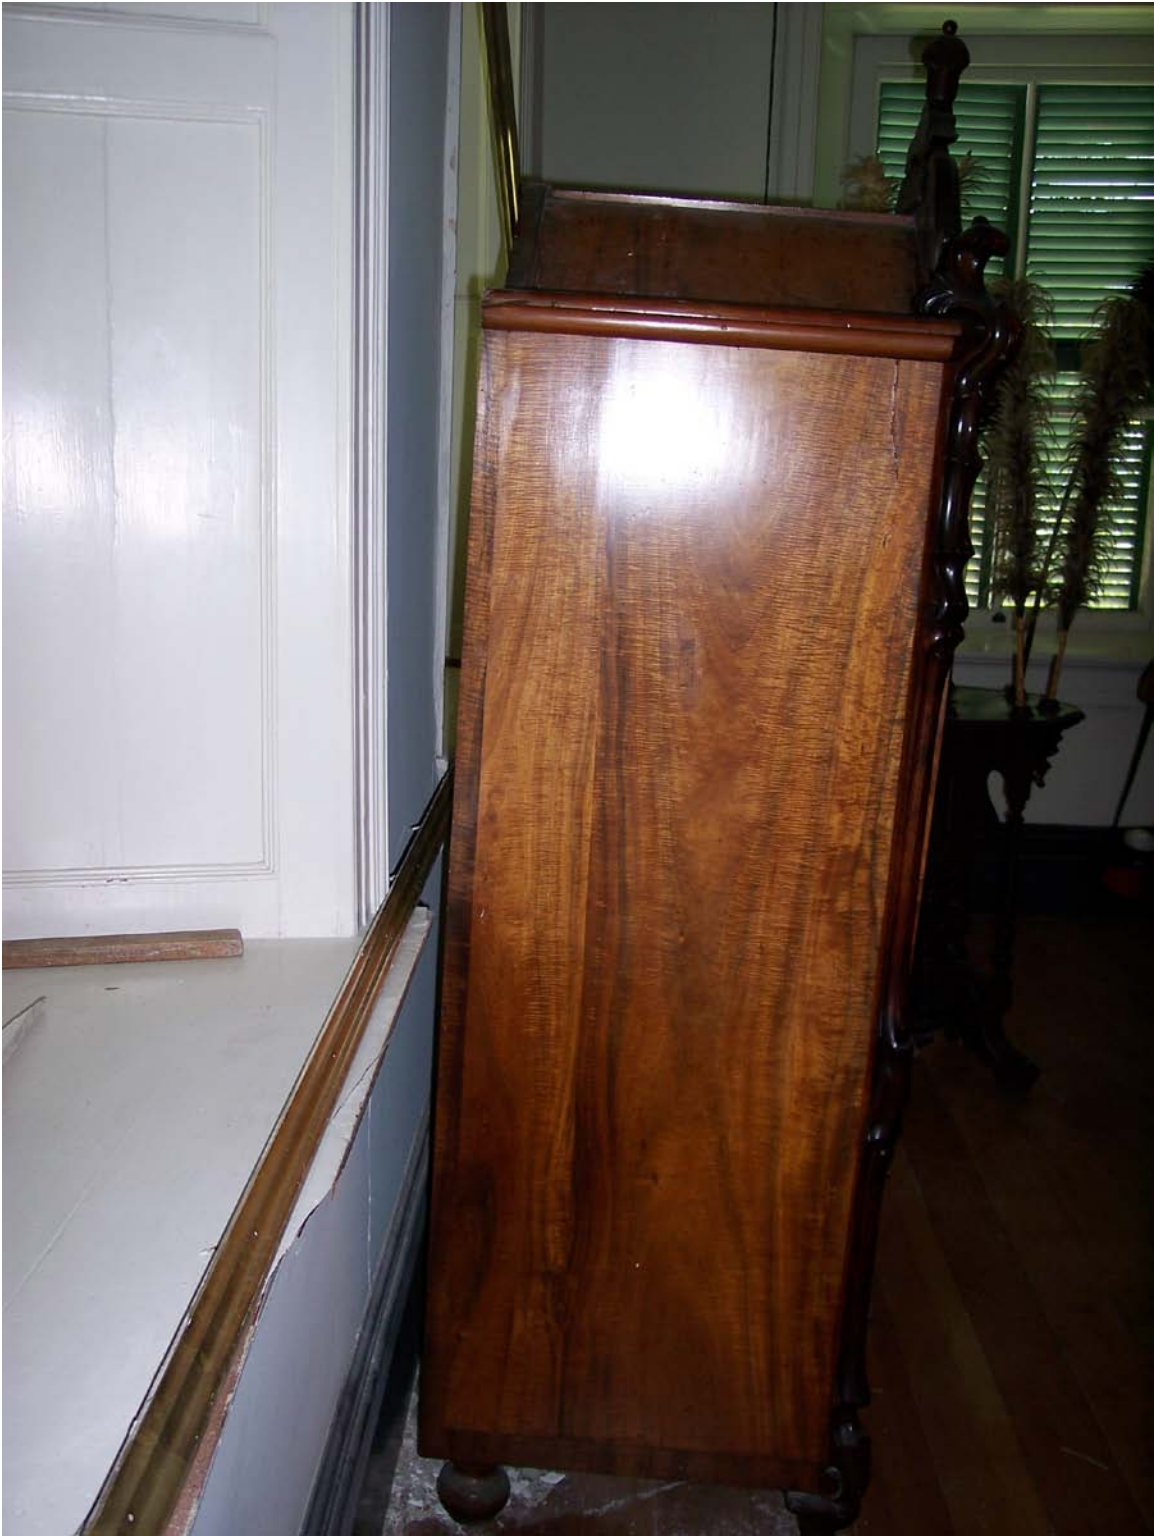
33.15. View of a chest of drawers in the bedroom for visiting royalty that appears to be tilting, but it is the room that is leaning. Note displacement of the wall behind the lower middle of the chest (view to the south). USGS photo by T.J. Takahashi, 10/28/2006 (tjt1821).

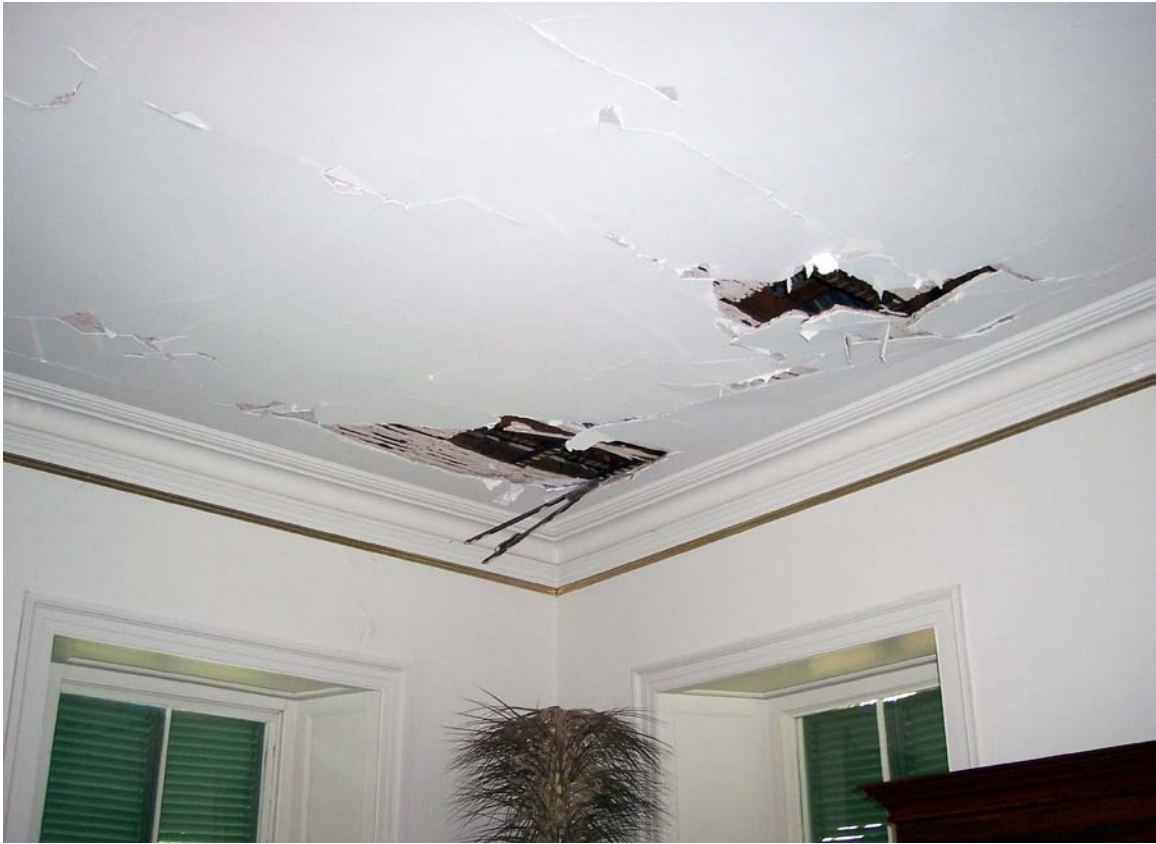
33.16. Close-up view of damage to the ceiling, where plaster separated from the wood lath. The lath remained intact, for the most part (view to the northeast). USGS photo by T.J. Takahashi, 10/28/2006 (tjt1847).

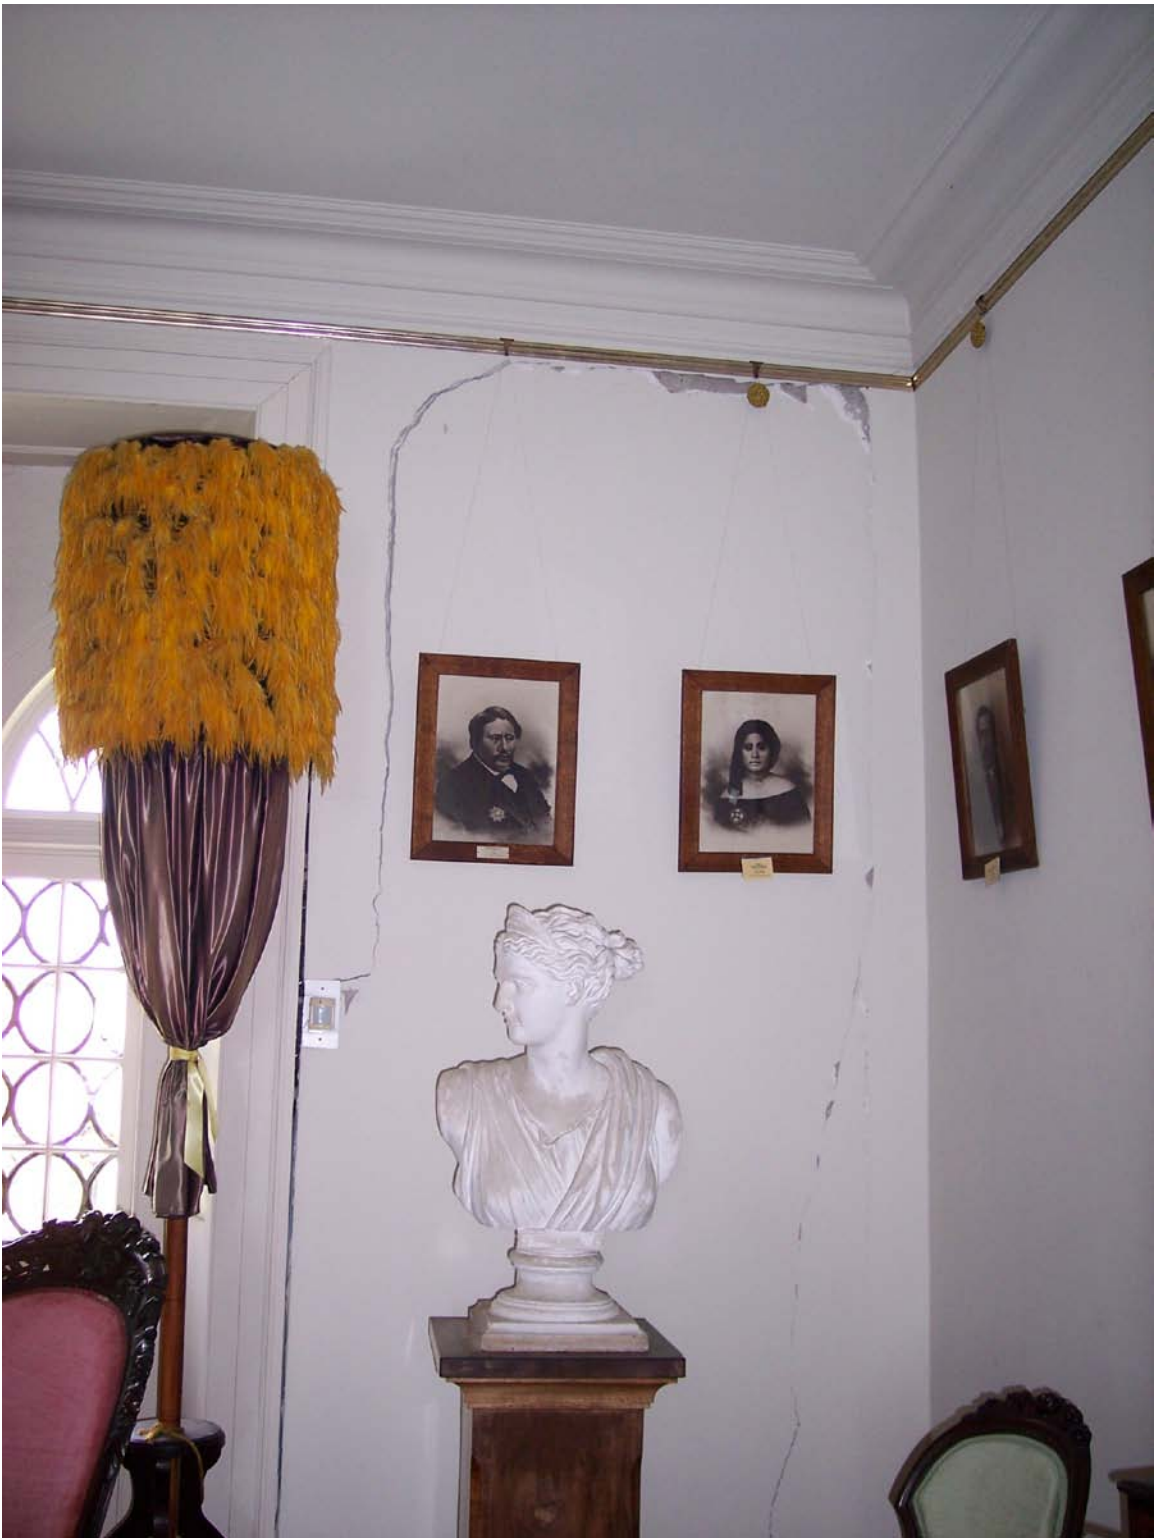
33.17. View of vertical cracks along the wall and lateral damage to the cornice (view to the east). USGS photo by T.J. Takahashi, 10/24/2006 (tjt1802).

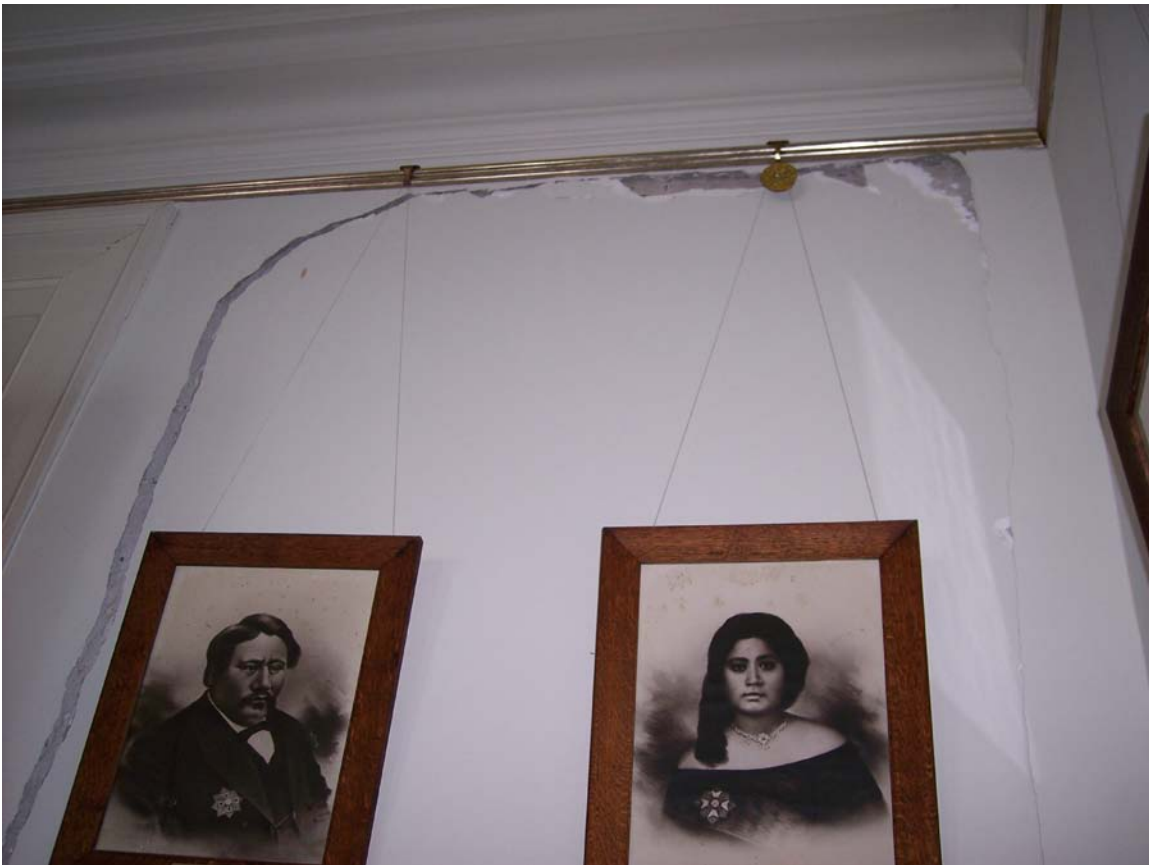
33.18. Close-up view of vertical and horizontal cracks along the wall and cornice (view to the east). USGS photo by T.J. Takahashi, 10/28/2006 (tjt1875).

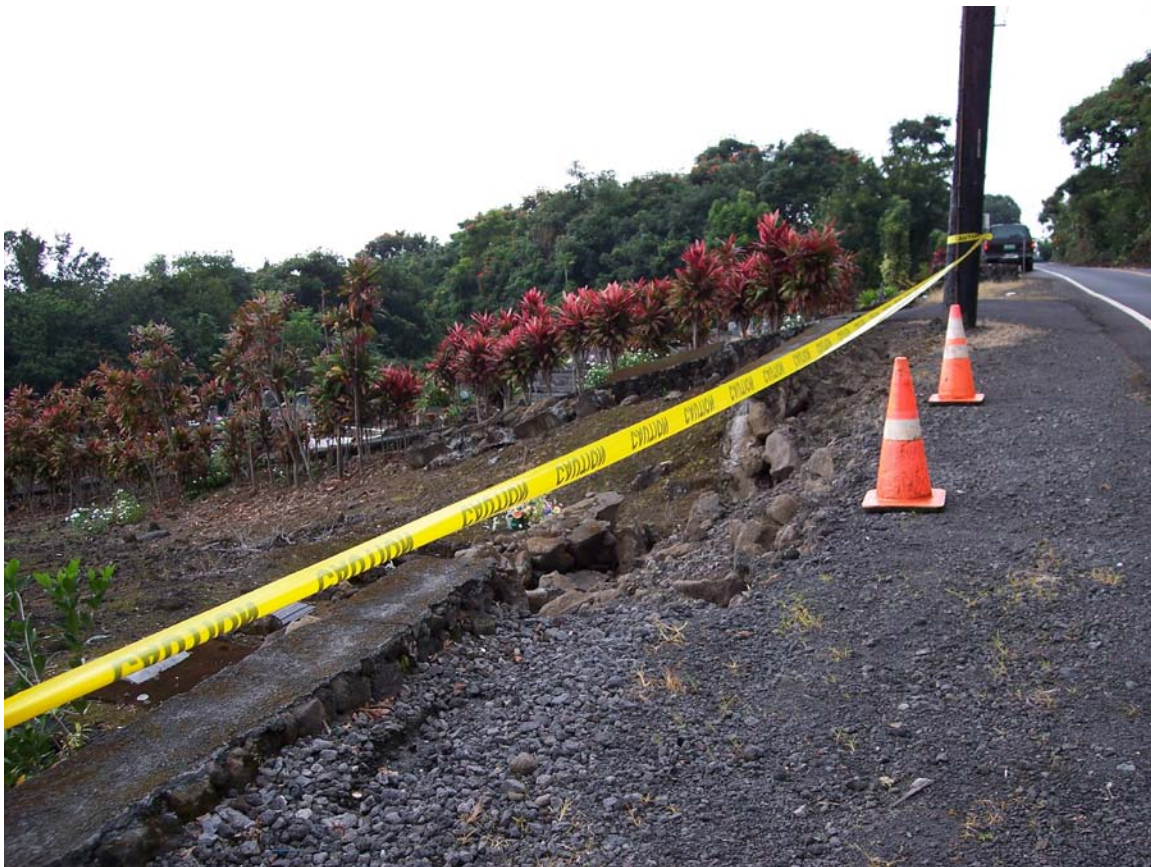
34.1. View of slumping roadway shoulder approaching yellow-tagged Hōlualoa Catholic Cemetery, restricting entry (view to the northwest). USGS photo by T.J. Takahashi, 10/24/2006 (tjt1692).

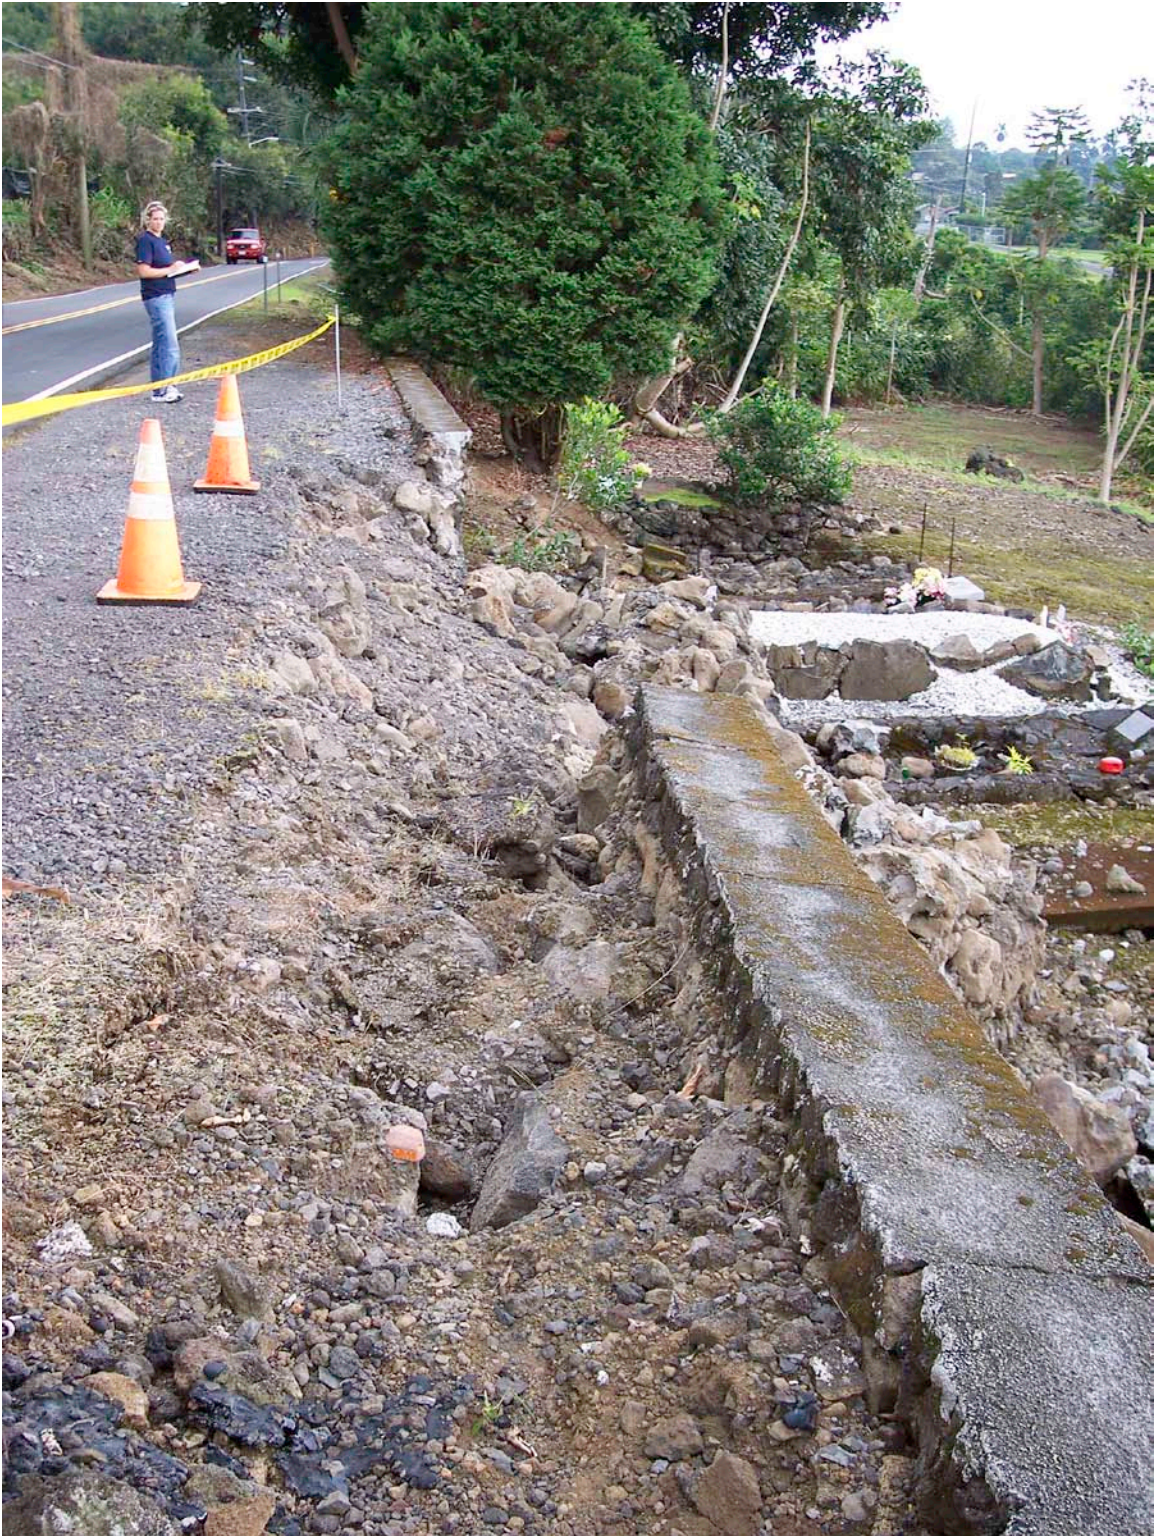
34.2. View of slumping roadway shoulder fronting the cemetery, and dislodged sections of the stone wall fronting the cemetery (view to the southeast). USGS photo by T.J. Takahashi, 10/24/2006 (tjt1693).

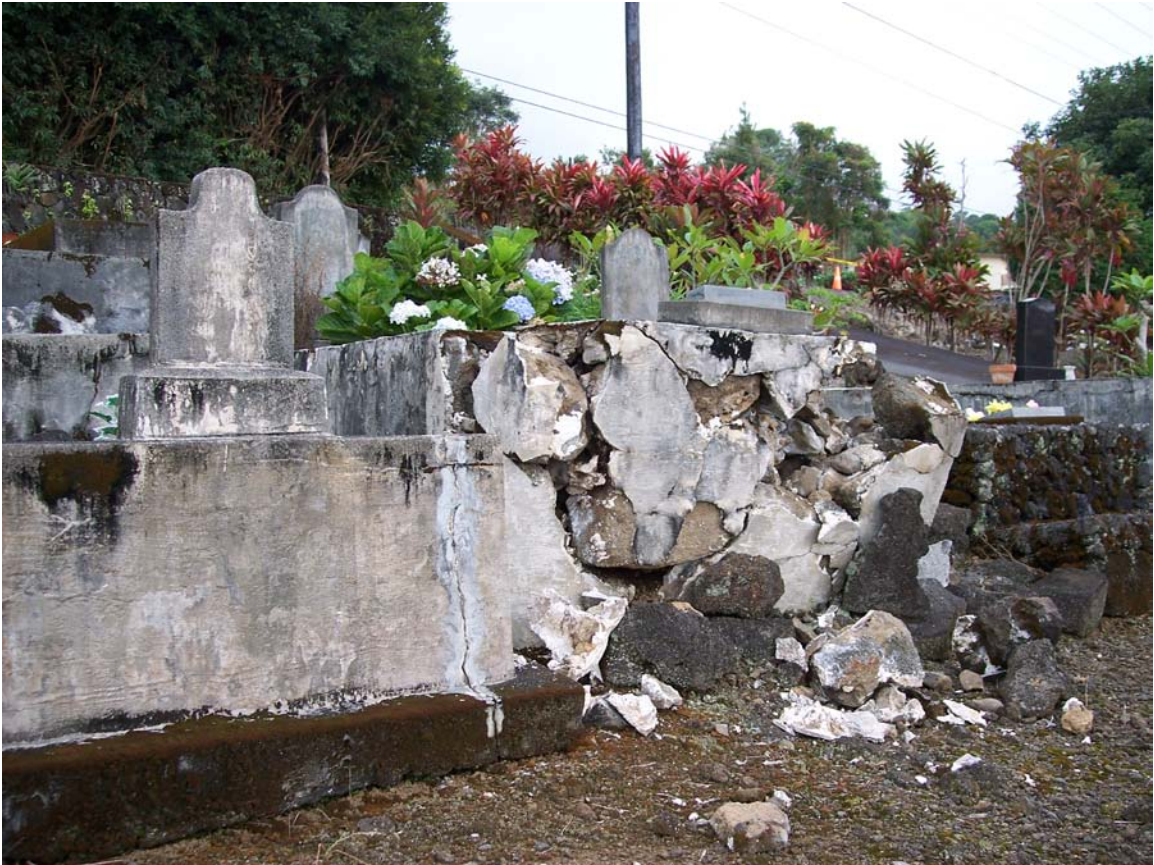
34.3. View of cracks in the base of the largest headstone (view to the east). USGS photo by T.J. Takahashi, 10/24/2006 (tjt1709).

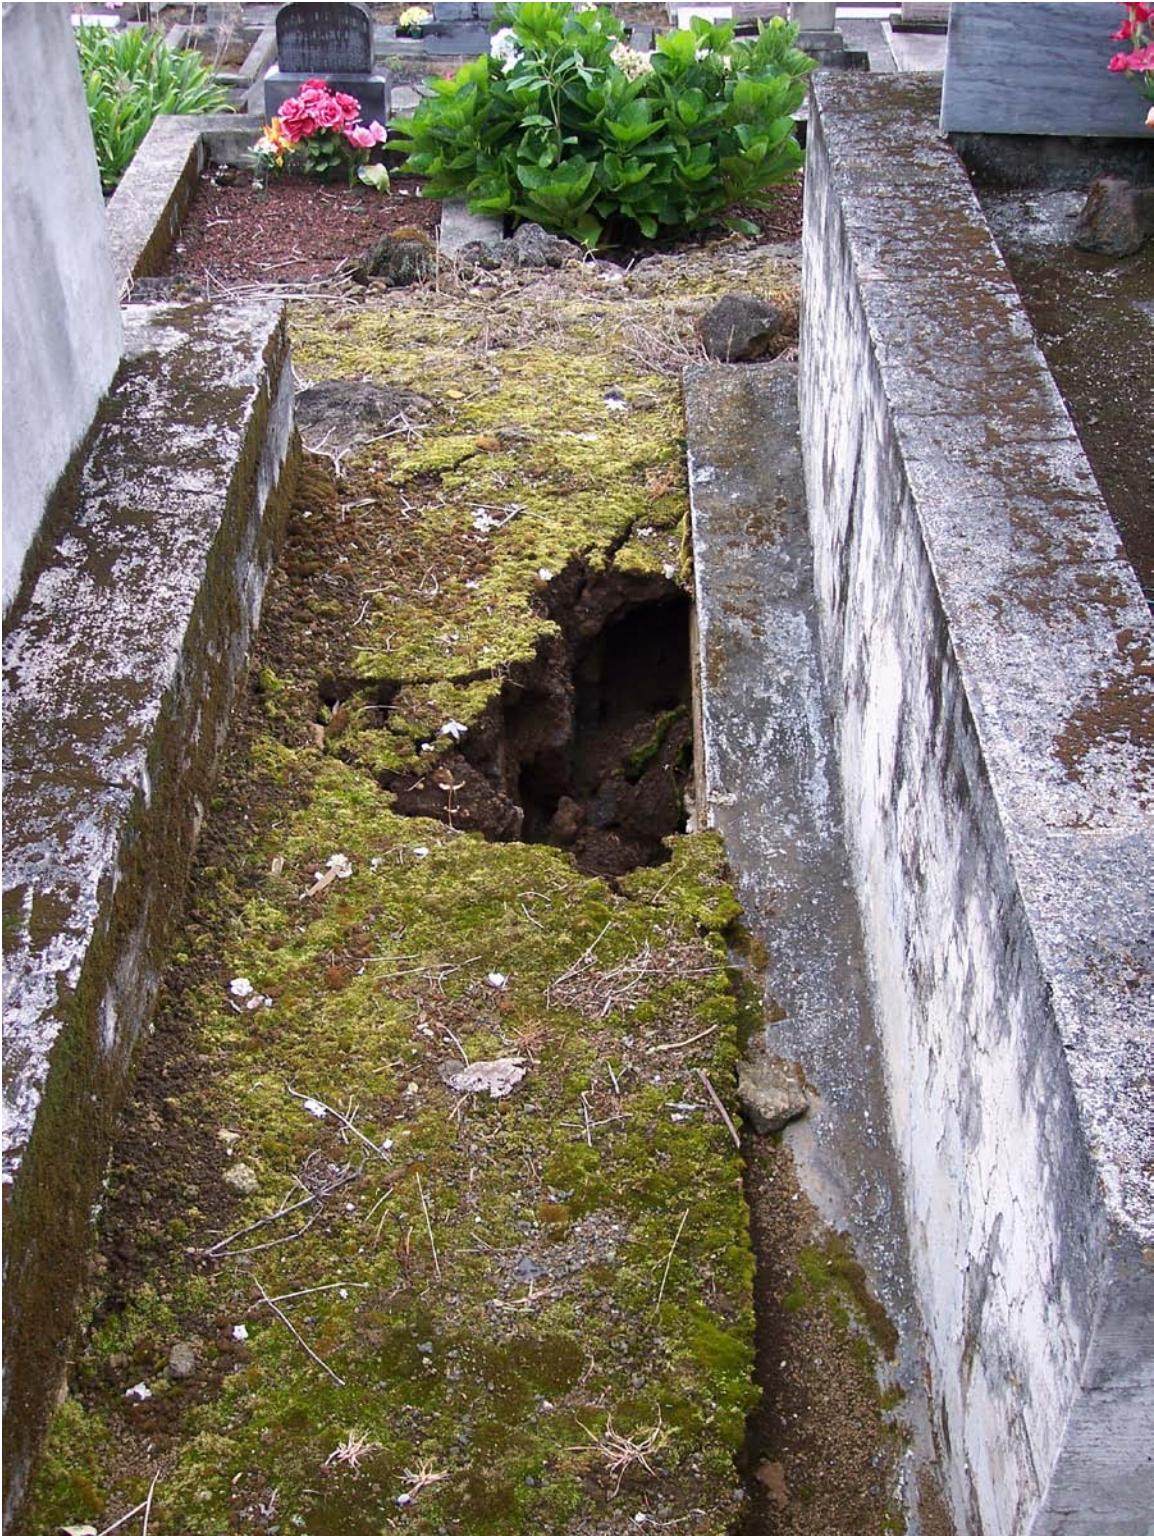
34.4. View of collapsed ground between cemetery plots (view to the west-southwest).  
USGS photo by T.J. Takahashi, 10/24/2006 (tjt1699).

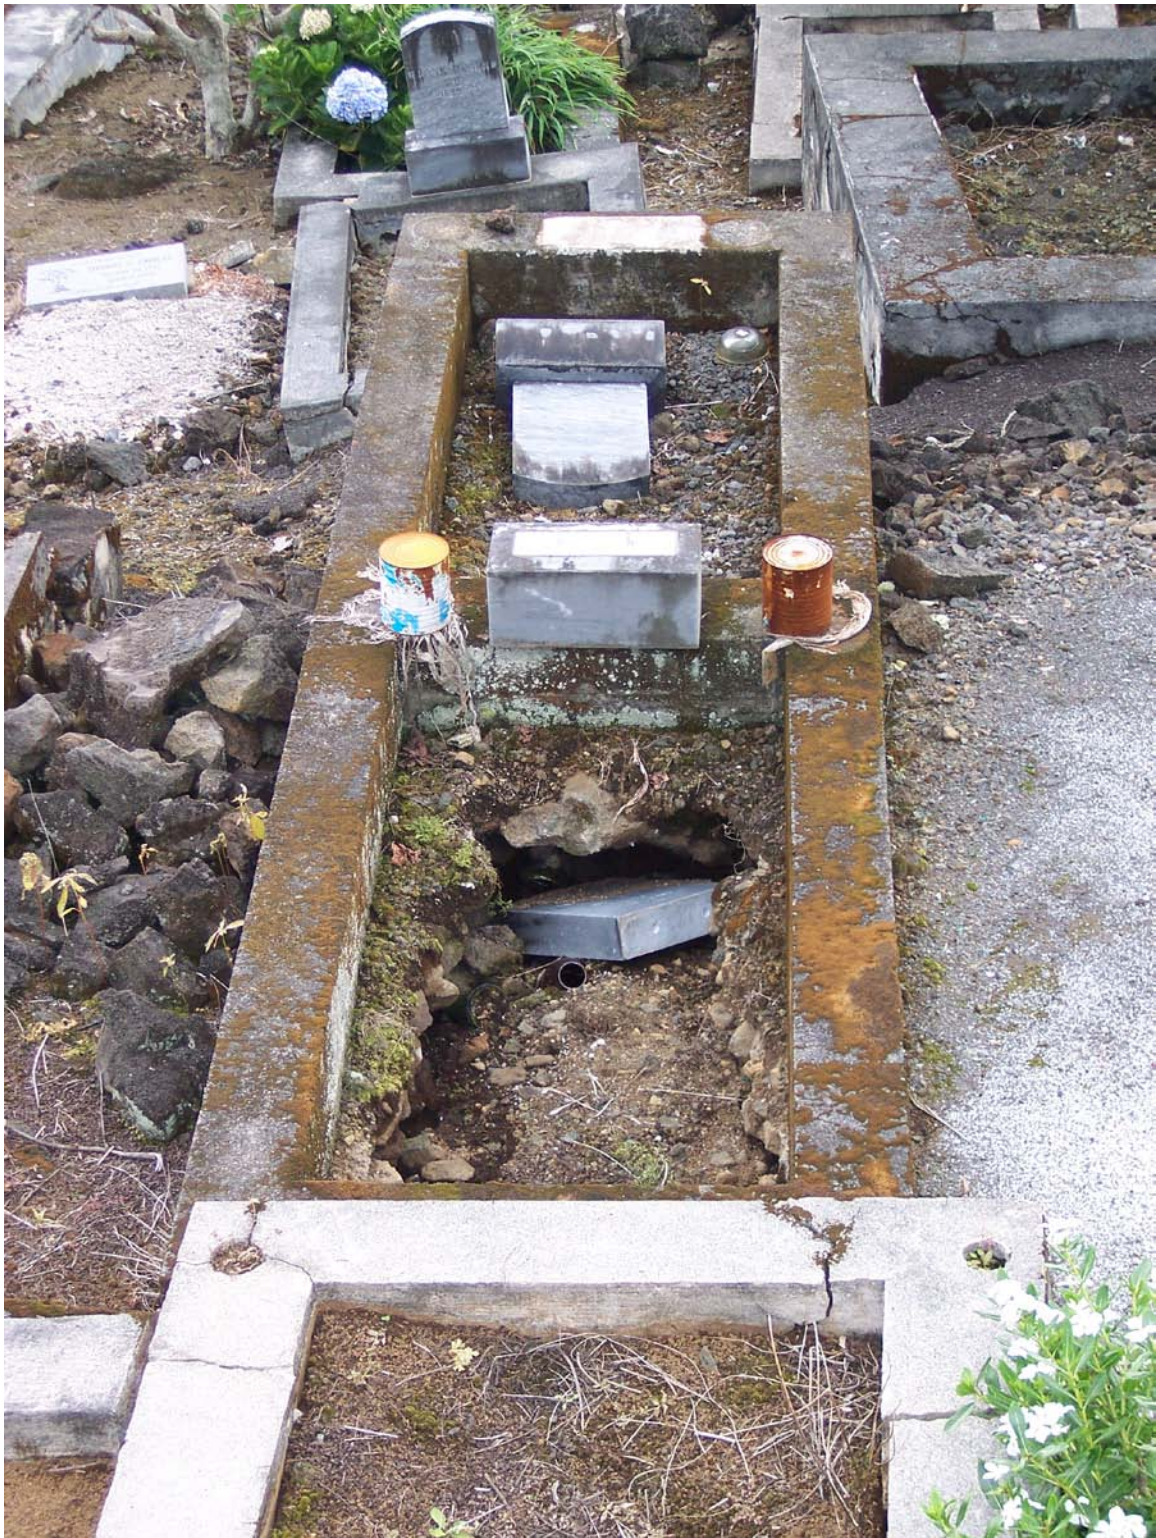
34.5. View of slumping cemetery plot and its collapsed headstone (view to the west-southwest). USGS photo by T.J. Takahashi, 10/24/2006 (tjt1695).

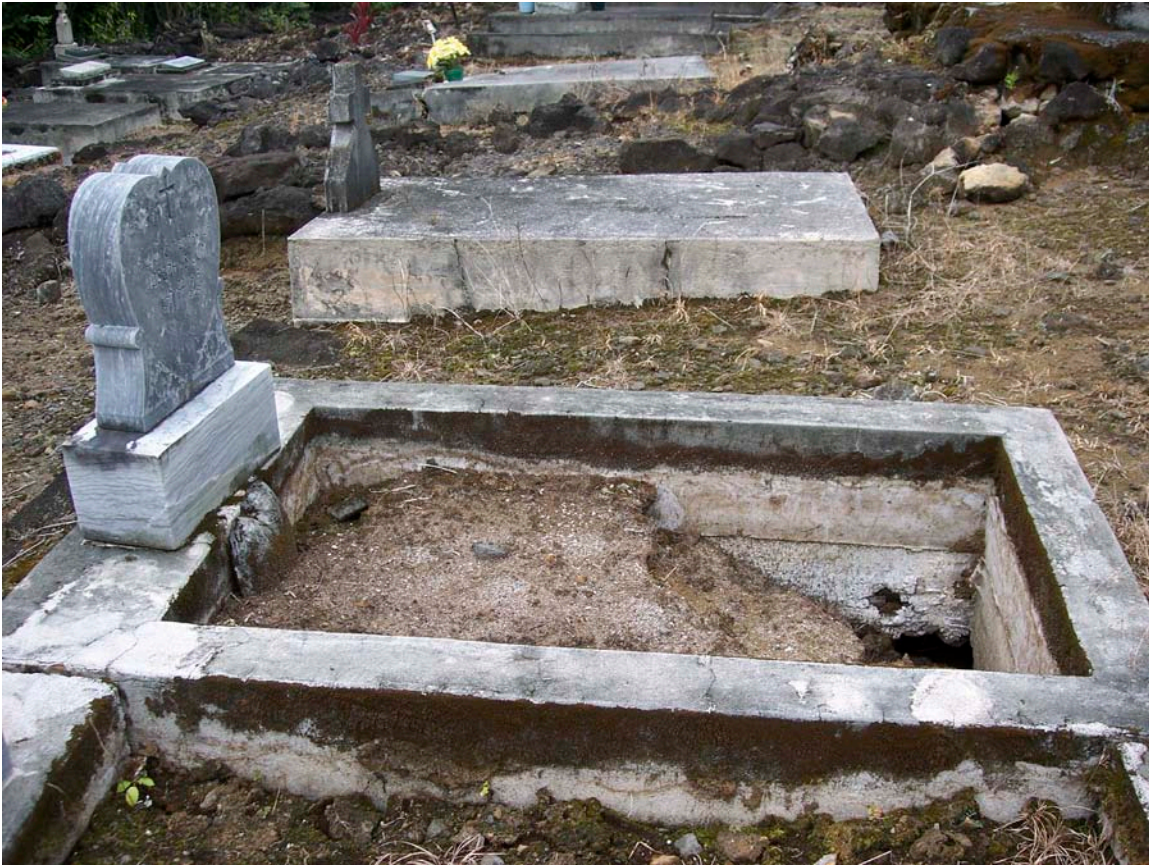
34.6. View of collapsed earth in a cemetery plot (view to the north-northwest). USGS photo by T.J. Takahashi, 10/24/2006 (tjt1708).

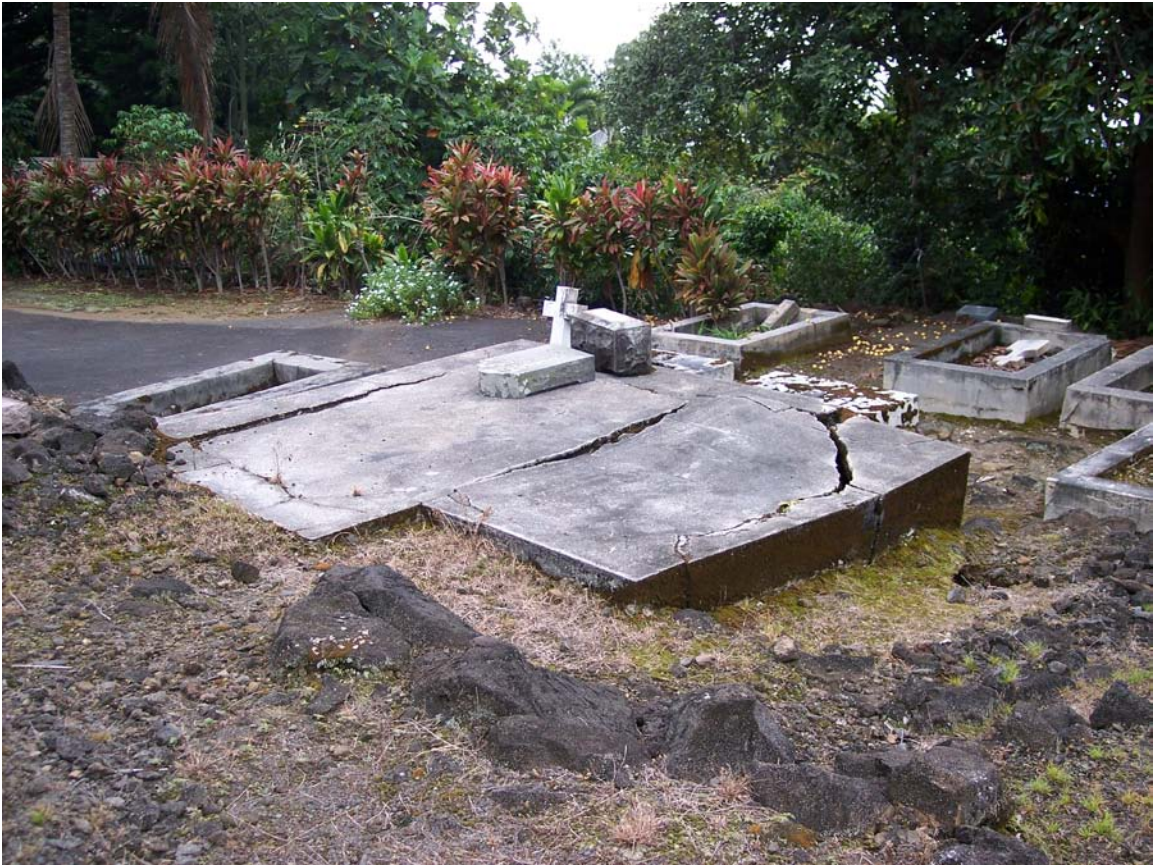
34.7. View of slumping ground that caused the slab to crack and the headstone to topple over (view to the south-southwest). USGS photo by T.J. Takahashi, 10/24/2006 (tjt1706).
